Wind Harvest Company Prototype -Windstar 530

Whitewater, CA | Installed 1988, Removed 1994

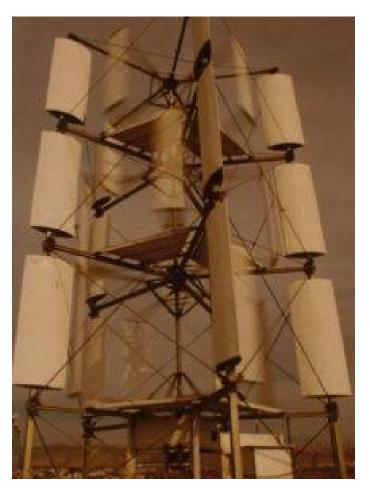
Model 530 Specifications	
Rotor Height (m)	25
Rotor Diameter (m)	5.4
Swept Area (m²)	161.5
Blade length (m)	3
Blade cord (m)	.44
Stator cord (m)	1.1
Number of modules	3
Number of blades per module	4
Number of stators	5
Rotor RPM	80
Solidity	33%
Generator	Induction
Voltage	460
# of phases	3
Generator RPM	1810
